USAAVRADCOM-TM-80-D-4

**DEVELOPMENT OF A LOW-COST FIELD FIX FOR THE
RU-21H AIRCRAFT ANTENNA**

I. E. Figge

February 1980

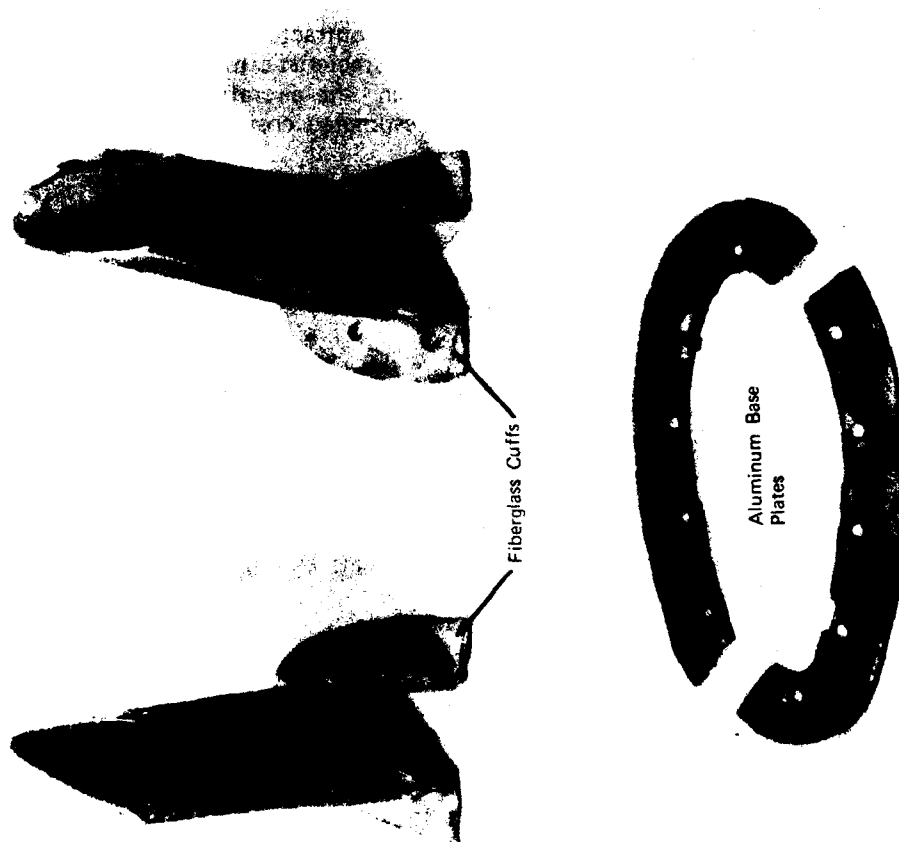
Figure 1. Contractor's antenna modification.

The RU-21H (guardrail) aircraft uses 18 fiberglass antennas in the performance of its mission. It was discovered that after 500 to 1000 hours of field use, a large portion of the antennas were failing as the result of fatigue cracks in the vicinity of the leading- and trailing-edge flange radii. A two-piece (spanwise split at mid-chord) fiberglass cuff repair (Figure 1) was developed, under contract, subjected to limited fatigue testing, and was in the process of being installed on the fleet of RU-21H aircraft. This fix required that the antenna be removed from the aircraft, shipped to the contractor for installation of the cuff repair, shipped to another facility for antenna characteristic measurements, and then returned to the user for installation and calibration on the aircraft. This effort required approximately a five-week aircraft downtime at an estimated cost of about \$1300 per antenna (\$23,400 per aircraft).
